Service Bulletin 241

September 26, 2012

FUSELAGE ATTACHMENT TO WING MAIN SPAR - INSPECTION & REINFORCEMENT

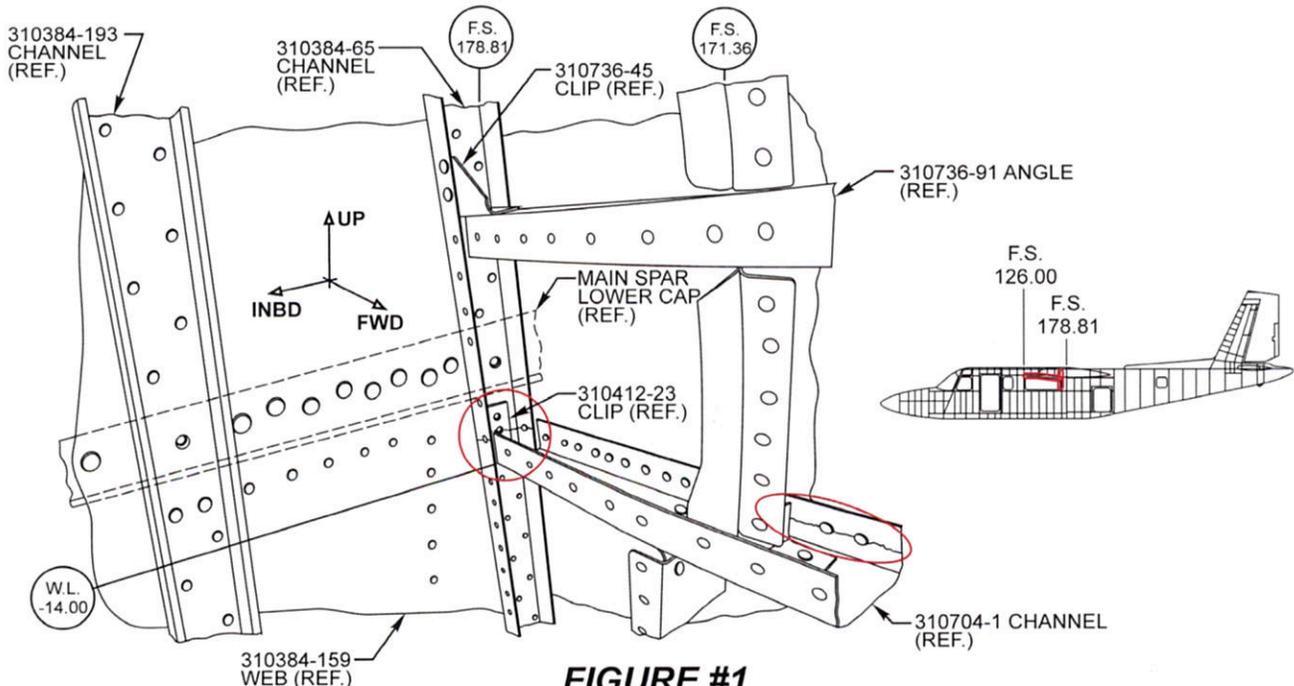
FIGURE #1

Aircraft have been found with cracks in the outer fuselage frame attachment to the lower wing main spar at F.S. 178.81 vertical channel (310384-65 LH & -125 RH). Additional damage has been found at the upper picture window channel (310704-1 LH & -2 RH), shear clip (310412-23 LH & -24 RH), aft cabin pressure web (310384-159), external wing to fuselage fillet (110151-33 LH -34 RH) and working or sheared fasteners.

VIEW LOOKING AFT & OUTBOARD @ LH AFT PRESSURE BULKHEAD / UPPER PICTURE WINDOW INTERSECTION
RH SIDE OPPOSITE, CABIN INNER FRAME
PANEL SKINS SHOWN REMOVED FOR CLARITY

This modification removes all the damaged or potential damaged sheet metal parts in the area of the fuselage to wing main spar joint. This modification primarily replaces joint parts with improved heavier machined parts. The modification cuts and removes the upper 18.5-inch section of the existing 310384-65/-125 channels and incorporates a heavier gage extruded channel as a replacement. The extruded channel was designed to nest into the lower remaining section of the existing channel. A vertical strap is cradled into the new frames making the joint Failsafe and provides improved fastener edge distance. Parts are being replaced for safety of flight to repair damage, prevent future damage and improve load paths.
